# **EXPERIMENTAL BEHAVIOUR OF A STEEL STRUCTURE UNDER NATURAL FIRE**

This paper reports on the results of a collaborative research project (Tensile membrane action and robustness of structural steel joints under natural fire, European Community FP5 project HPRI - CV 5535) involving the following institutions: Czech Technical University (Czech Republic), University of Coimbra (Portugal), Slovak Technical University (Slovak Republic) and Building Research Establishment (United Kingdom). It consists of an experimental programme to investigate the global structural behaviour of a compartment on the 8-storey steel-concrete composite frame building at the Cardington laboratory during a BRE large-scale fire test, aimed at the examination of the temperature development within the various structural elements, the corresponding (dynamic) distribution of internal forces and the behaviour of the composite slab, beams, columns and connections.

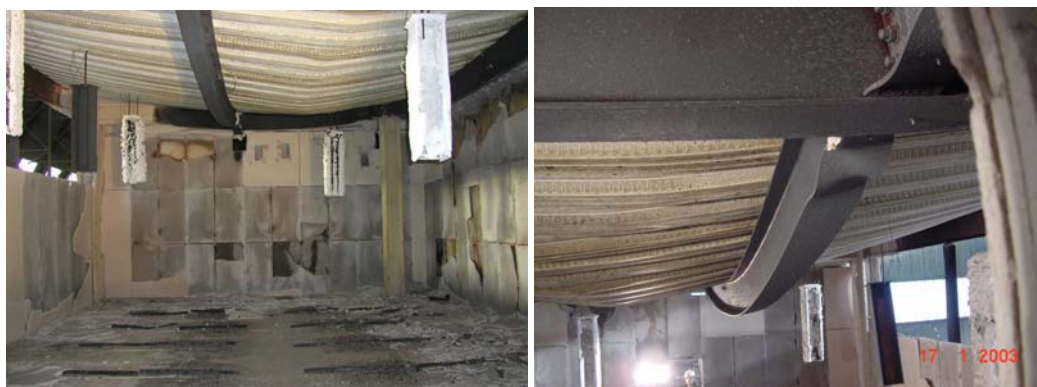
During the test the predicted local collapse of the structure was not reached, see Fig 7. Fig. 8 compares the temperatures recorded in the compartment with the parametric curve presented in Eurocode 1, Annex A [19]. The quantity of thermal load and the dimensions of the opening on the facade wall were designed to achieve a representative fire in the office building. The maximum recorded compartment temperature near the wall (2 250 mm from D2) was 1107.8 °C after 54 minutes, while the predicted temperature was 1078 °C in 53 min, see [16].

Fig 7 Compartment after fire, residual deformation 925 mm, no local collapse of structure

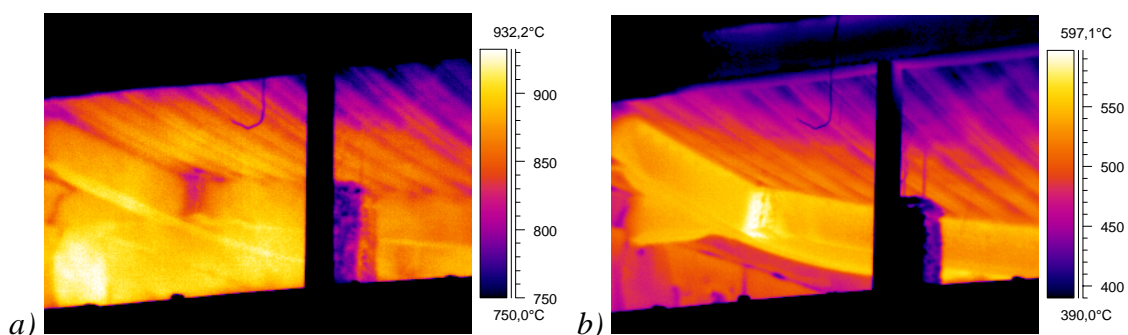
In the heating phase, the joint temperature is significantly lower than the remote bottom flange, which is usually the critical element that defines the limiting temperature of the beam; in contrast, the cooling down in the joints was slower. Using the thermal cameras it was possible to observe this effect, see Fig. 13.

At the maximum temperature, the joint temperature was around 200 °C lower than the limiting temperature of the beam. The first bolt row from the top was significantly cooler than the lower bolts, because of shielding by the adjacent slab and column. The end-plate was hotter than the bolts at the same level due to the ratio of the bolt diameter to the end-plate thickness (20 mm).

Fig. 13 Fin plate connection D1-2 recorded by thermo imaging camera a) during heating after 58 min. of fire; b) during cooling after 92 min

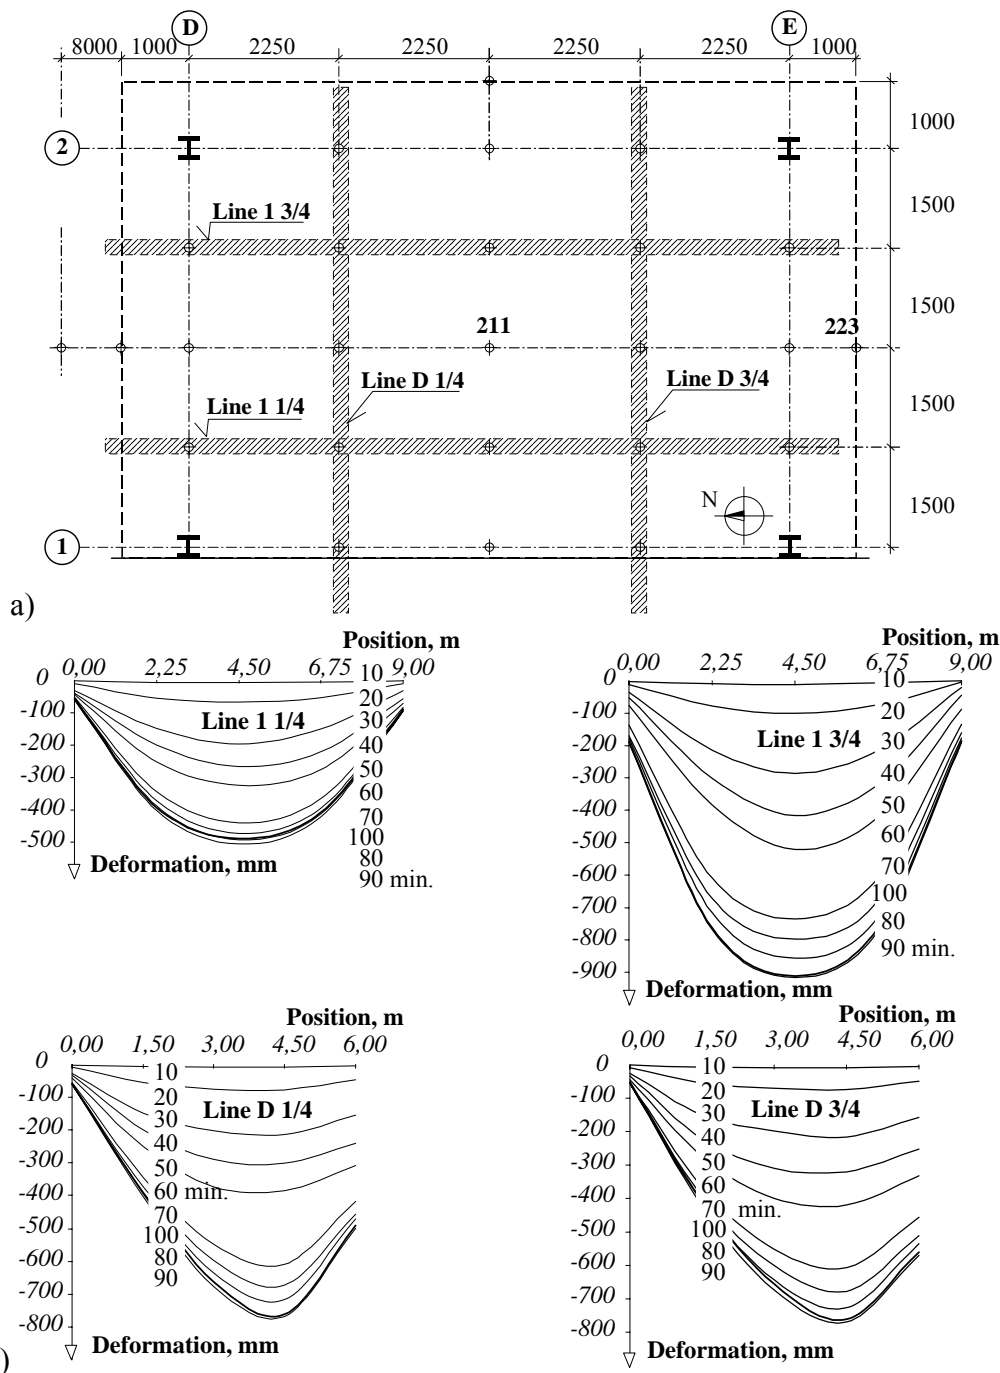
The maximum deflections were not recorded by the displacement transducers because its range was limited to 1000 mm minus the initial offset. From the video cameras on the 5th floor it is possible to recalculate a maximum vertical displacement of about 1 200 mm. Fig. 15 shows the vertical displacement recorded in beams D1-E1, D1/2-E1/2, D2-E2. Comparing the different secondary beams, it is observed that during the heating phase, the beam with a lower displacement is the beam near the window, because of lower temperatures, while the beam near the internal wall shows the biggest displacement. In the cooling phase, both these beams partially recovered.

Fig. 15 Vertical deformations; a) measured points, b) reached values at drawn lines,  
 \* deflection more than 900 mm may be affected by the limited record in transducers

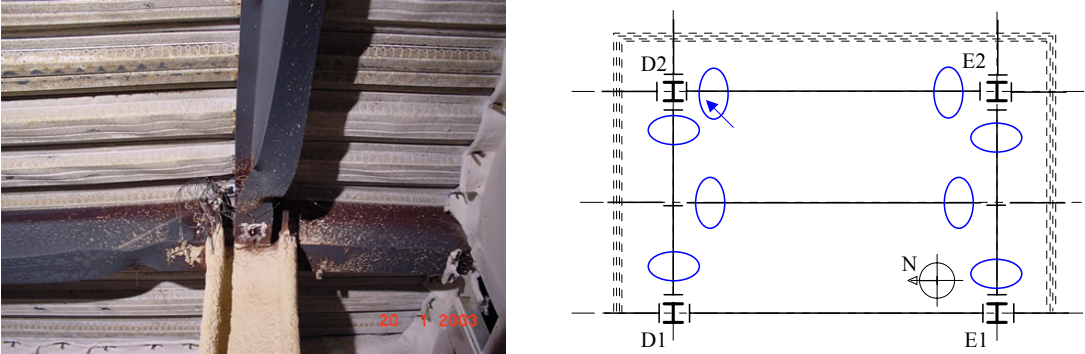
Local buckling of the beam lower flange was one of the main failure mechanisms. It is observed in the lower beam flange and web adjacent to the joints, see Fig. 16, the concrete slab having restrained the upper flange. This local buckling occurs during the heating phase after about 23 min. of fire (observed by thermo imaging camera), due to the restraint to thermal elongation provided by the adjacent cooler structure and the structural continuity of the test frame. The heated lower flange of the beam is unable to transmit the high normal forces generated in the lower flange of the beam to the adjacent beams/columns after closure

of the gap in the lower part of the connections. The beam could be assumed to behave as ‘simply supported’, allowing larger mid-span deflections to develop.

Fig. 16 Local buckling of beam lower flange

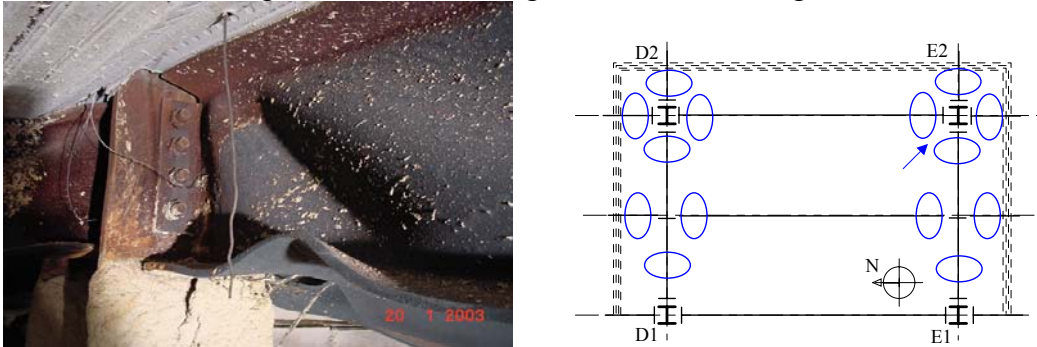
As temperature and the associated deformations increase, the shear resistance of the beam web was also reached, see Fig. 17.

Fig. 17 Beam web in shear

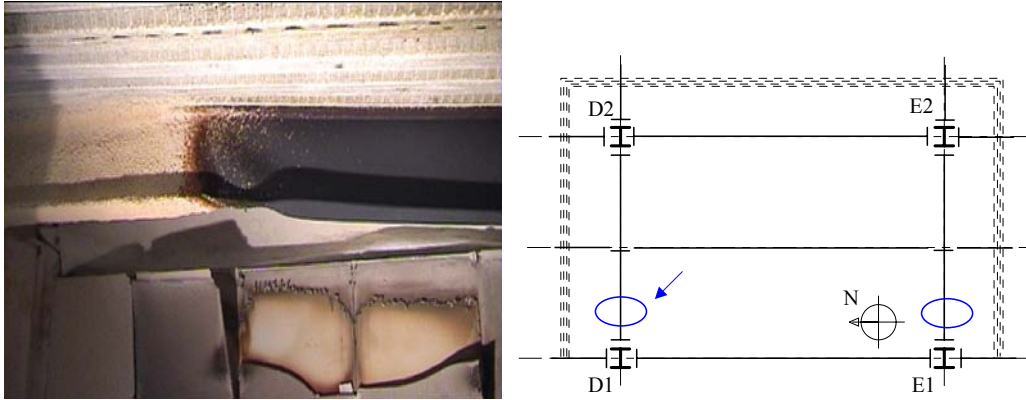
The formation of a plastic hinge in the beam cross-section next to the protected zone was one of the main observed mechanisms in the main beam D1/2, see Fig. 18. This hinge is induced by lateral-torsional buckling during the first stage of the heating phase, due to the restraint to thermal elongation provided by the adjacent protected section. This behaviour is associated with the local loss of stability in the bottom flange. Subsequently, during the second stage of the heating phase, the beam rotates around this point due to the large mid-span deflection.

Fig. 18 Plastic hinge in the unprotected beam cross-section close to the end of the fire protection

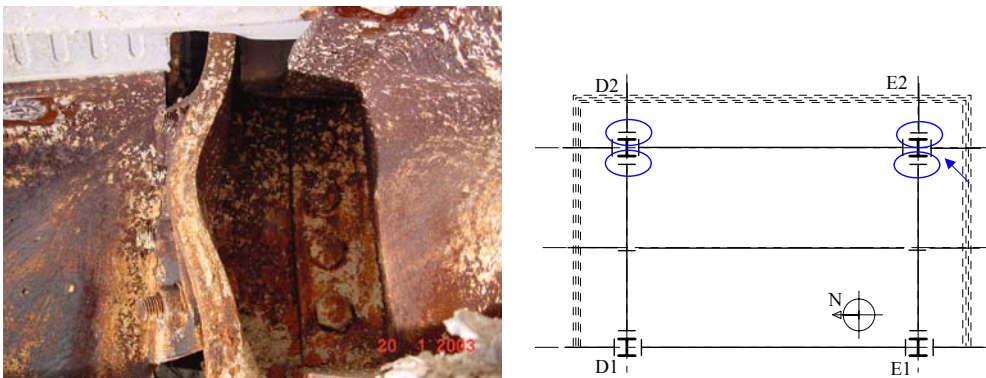
The buckling of the column flange in compression was observed in the major axis beam-to-column joints, see Fig. 19. This behaviour results from the small column flange thickness ( $t = 21.4 \text{ mm}$ ) and the small distance between the bolts, the bolted end-plate behaving as a welded joint. This behaviour was observed in both columns flanges of the two beam-to-column joints (D2; E2).

Fig. 19 Buckling of column flange in compression, column E2

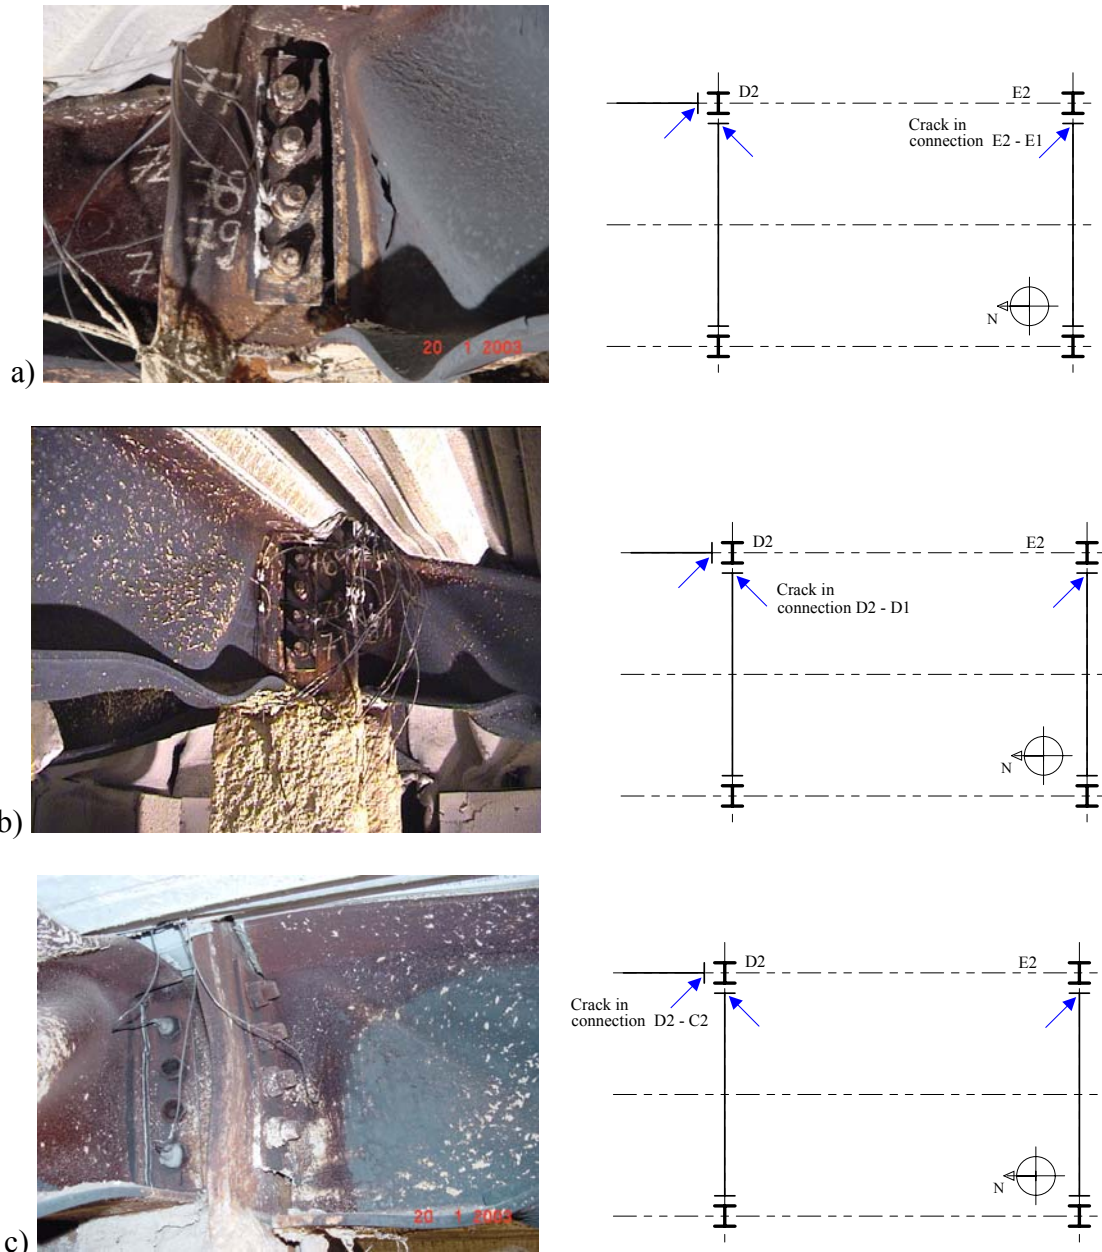
Fracture of the end-plate along the welds was observed, caused by the horizontal tensile forces during cooling of the connected beam under large rotations associated with flexible end-plate joints, see Fig. 20. The fracture occurred along one side of the connection only, while the other side remained intact. After one side has fractured, the increased flexibility allowed larger deformations without further fracture. This behaviour was observed in both the major axis beam-to-column joints (D2-D1; E2-E1) and the minor axis beam-to-column joints (D2-C2).

Fig. 20 Fracture of the end-plate along the welds, connections D2-D1; E2-E1, D2-C2

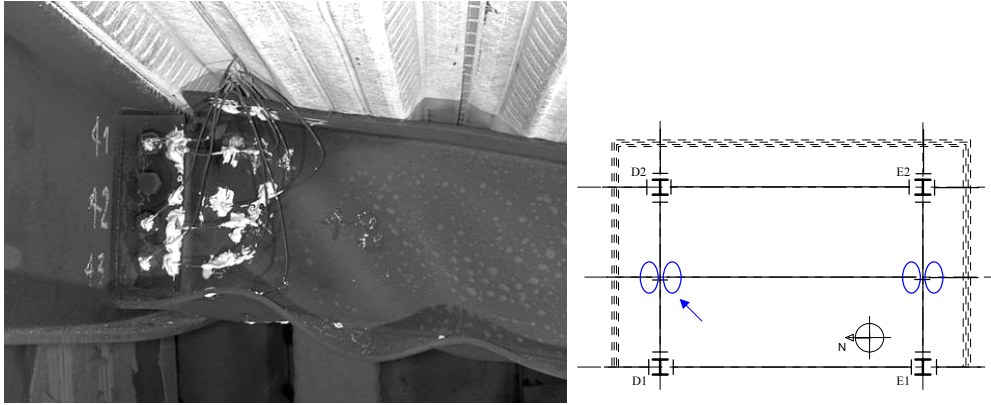
The elongation of the holes in the beam web in the tension/compression part of the fin plate connection is due to the associated large rotations, see Fig. 21. The elongation of the holes occurred on the web of connected beam, while the fin-plate remained intact: the beam web thickness (6 mm) is smaller than the fin-plate (10mm); again, the elongation of the holes of the beam web leads to increased joint flexibility, allowing larger deformations without further fracture.

Fig. 21 Elongation of holes in the beam web in fin plate connection

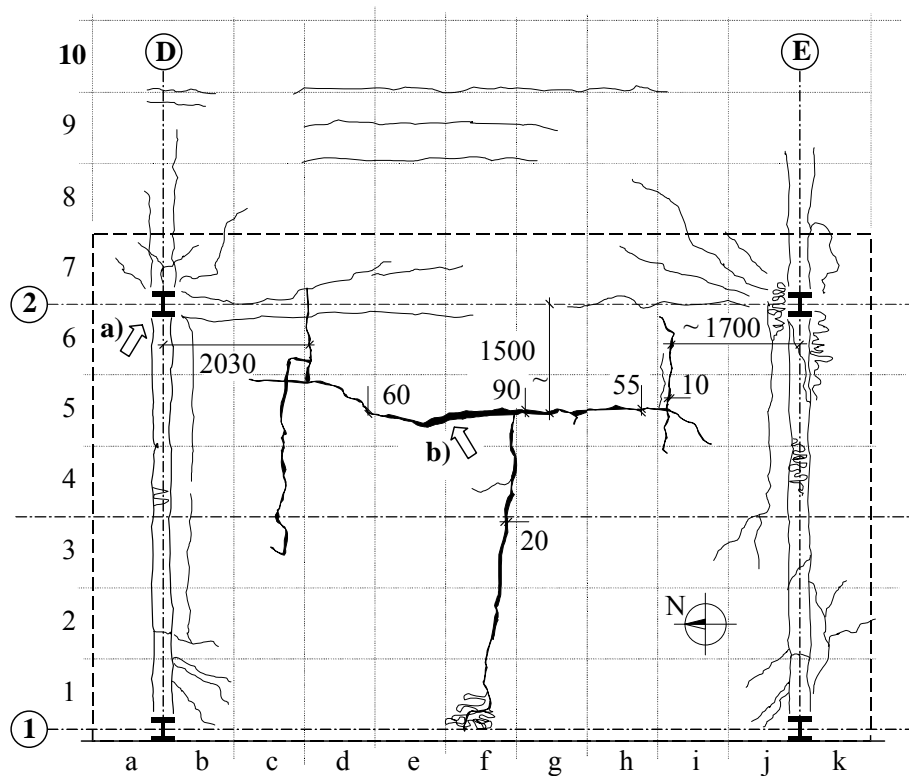
Fracture in the concrete slab was observed, a large crack propagating from the face of the column flange parallel to the beam (D-E2), see Fig. 22. This crack developed due to the tension in the concrete slab, along the weak zone in the composite beam - flange extremity. After the concrete cracked, the joint stiffness gradually decreased. Secondary cracks occurred perpendicular to, and continuous across, the connections on both sides of the slab, see Fig. 23. The maximum vertical displacement occurred along a line of mesh reinforcement overlap (without adequate attachment). This led to slippage of the mesh and the corresponding behaviour of the slab was “de facto” without reinforcement.

Fig. 22 Mesh of cracks in concrete slab

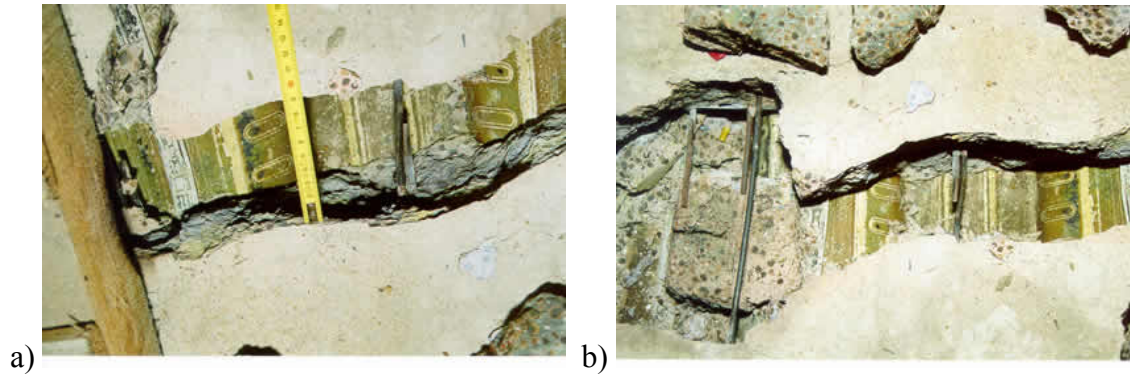
Fig. 23 Reinforcement mesh a) slippage and cracking near to the column D2, largest crack/opening in the mid-span

The cameras above the fire compartment recorded loss of the integrity limit state of the concrete slab after 54 min. The opening of the composite slab took place around column E2 by a punching mechanism due to the tension in the concrete slab in the edge compartment. Furthermore, many tiny cracks were observed in different areas of the concrete slab.
