# **EXPERIMENTAL BEHAVIOUR OF A STEEL STRUCTURE UNDER NATURAL FIRE**

This paper reports on the results of a collaborative research project (Tensile membrane action and robustness of structural steel joints under natural fire, European Community FP5 project HPRI - CV 5535) involving the following institutions: Czech Technical University (Czech Republic), University of Coimbra (Portugal), Slovak Technical University (Slovak Republic) and Building Research Establishment (United Kingdom). It consists of an experimental programme to investigate the global structural behaviour of a compartment on the 8-storey steel-concrete composite frame building at the Cardington laboratory during a BRE large-scale fire test, aimed at the examination of the temperature development within the various structural elements, the corresponding (dynamic) distribution of internal forces and the behaviour of the composite slab, beams, columns and connections.

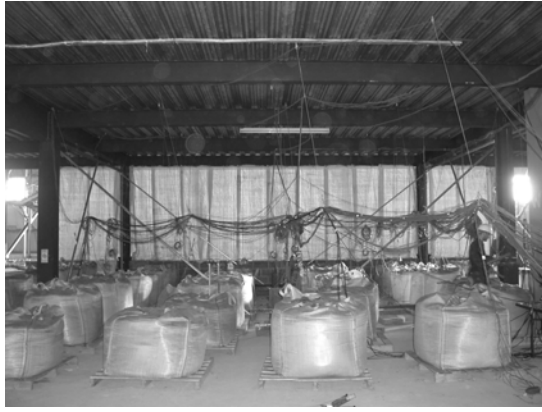
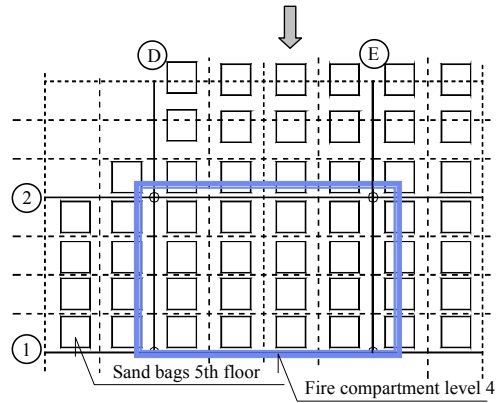
Fig. 2 Sandbags on the 5th floor

The mechanical load was simulated using sandbags, each weighing 1100 kg. Figure 2 illustrates the loaded area on the 5th floor. In addition to the self-weight of the structure, sand bags represented the following mechanical loadings: the remaining permanent actions, 100% of variable permanent actions and 56% of live actions. The mechanical load was chosen so that local collapse of the floor would be reached under fire, based on analytical and FE simulations [17].

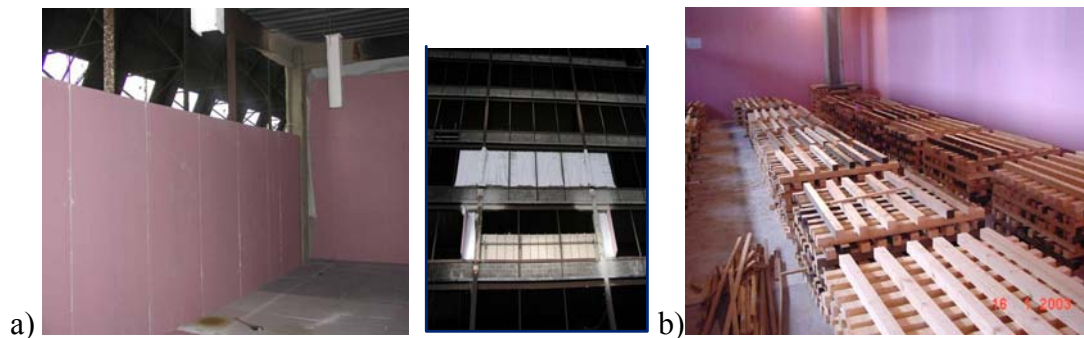
Fig. 3 Compartment; a) walls and b) fire loading

The fire load was provided by  $40 \text{ kg/m}^2$  of wooden cribs (moisture contents  $< 14\%$ ) covering the compartment floor area (Fig. 3). The fire compartment was bounded with three layers of plasterboard (15 mm + 12.5 mm + 15 mm) with a thermal conductivity around 0.19-0.24 W/mK. In the external wall (gridline 1) the plasterboard was fixed to a 1.5 m high brick wall. An opening 1.27 m high and 9 m long simulated an open window to ventilate the compartment and to allow the observation of the behaviour of the various elements. Preliminary calculations of the complex simulation of fire development predicted a short and hot fire [16].

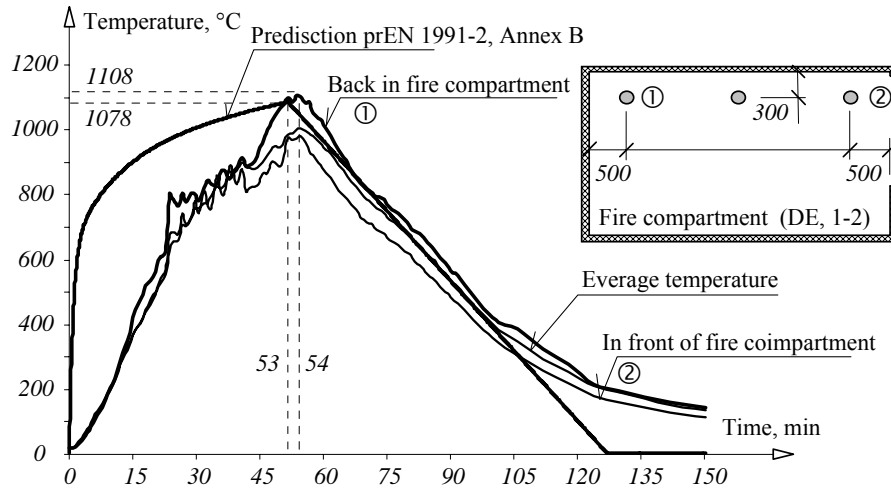
Fig. 8 Compartment temperature.

During the test the predicted local collapse of the structure was not reached, see Fig 7. Fig. 8 compares the temperatures recorded in the compartment with the parametric curve presented in Eurocode 1, Annex A [19]. The quantity of thermal load and the dimensions of the opening on the facade wall were designed to achieve a representative fire in the office building. The maximum recorded compartment temperature near the wall (2 250 mm from D2) was 1107.8 °C after 54 minutes, while the predicted temperature was 1078 °C in 53 min, see [16].

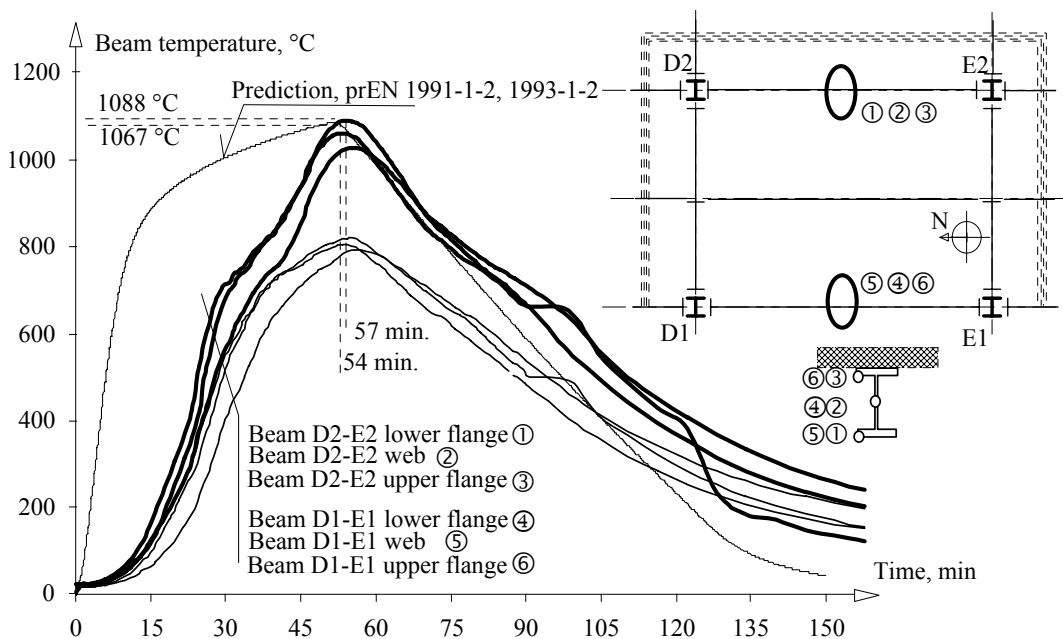
Fig. 9 Differential relative temperature variation within the beams D1-E1; D2-E2

Measurements of the temperature in the mid-span beams were taken on the bottom flange, on the web and on the upper flange. A summary of the temperatures recorded in the beams is presented in Fig. 9. The maximum recorded steel temperature of 1087.5°C occurred after 57 minutes of fire, on the bottom flange of beam DE2 in the middle of the section. By calculation, using an iterative procedure for the heat transfer into the unprotected steel structure, see eq. 4.24 [20], a temperature of 1067 °C in 54 min was predicted.

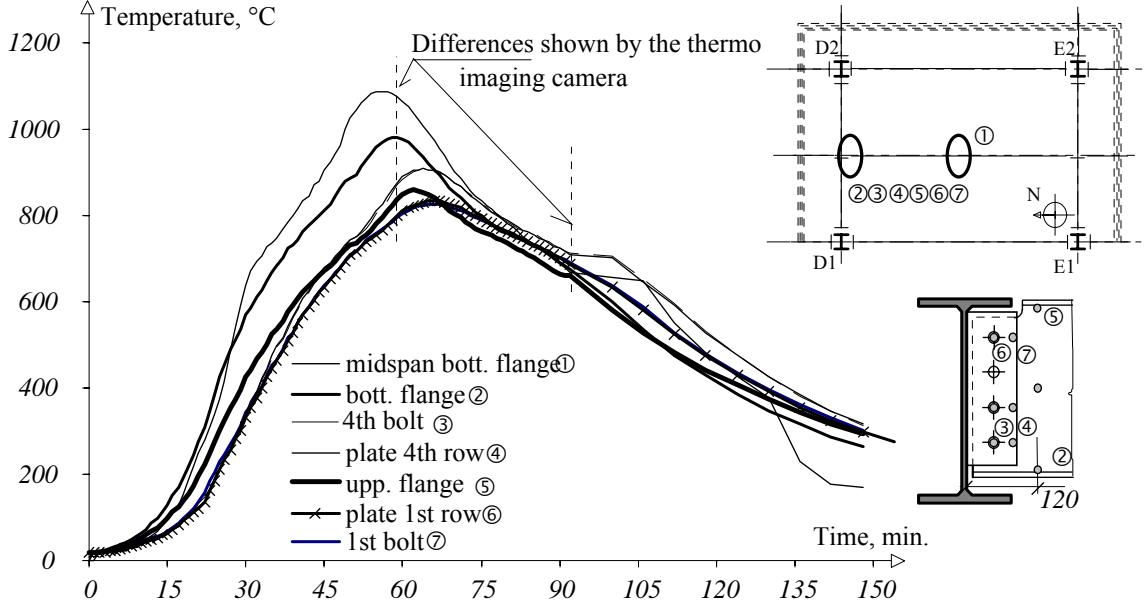
Fig. 10 Differential relative temperature variation within the beam-to-beam fin plate connection D1/2-E1/2

Measurements of the temperature in the connections were taken on the beam adjacent to the connection, in the plate and in the bolts. A summary of the temperatures recorded in the connections is presented in Fig. 10.

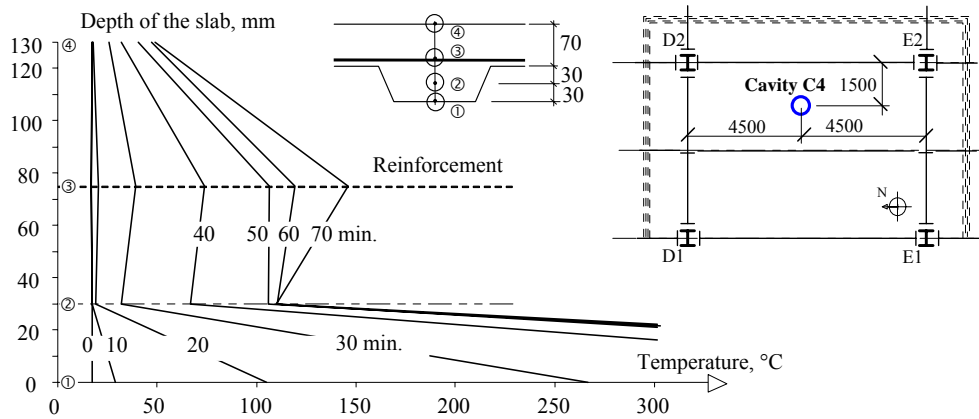
Fig. 14 Differential relative temperature variation within slab over the rib, cavity C4

A summary of the temperatures recorded in the slab is presented in Fig. 14 for temperatures in the reinforcement over the rib.
